Flight Test – FINAL REPORT – Revision 1 - (3/30/11)

Beechcraft King Air 90 Blackhawk

Alpha Systems Angle of Attack Stall Warning System

This Flight Test was flown to analyze the information provided by the Alpha Systems Angle of Attack (AOA) Stall Warning System as displayed on the Legacy indicator in six normal flight configuration and attitude combinations of the Beechcraft King Air 90 Blackhawk aircraft to determine the usefulness of that information at enhancing safety in the operation of general aviation aircraft.

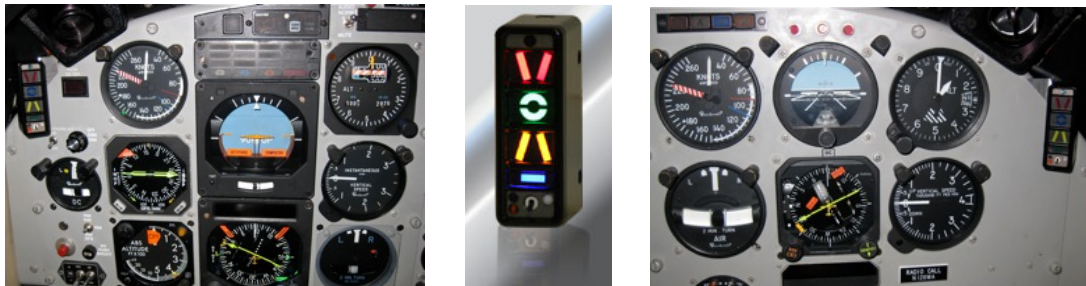
The Alpha Systems AOA Stall Warning Legacy Electronic Display System provided visual and audible indications as shown in Figure 1 and Table II below:

**Alpha Systems AOA Stall Warning Legacy Electronic Display
Dual Legacy AOA Indicators in a King Air 90**

Condition	Display Indication
Cruise	Blue Bar
Slow Cruise	Blue Bar and Amber Chevron
Very Fast	Amber Chevron
Fast	Amber Chevron and Lower Half of Green Donut (Three beeps audible at this indication)
Slightly Fast	Lower Half of Green Donut
On Speed (OAA)	Full Round Green Donut
Slightly Slow	Upper Half of Green Donut
Slow	Upper Half of Green Donut and Red Chevron
Very Slow	Red Chevron

With Gear Down/Flaps Full and 300 Ft-Lbs torque set at 94 KIAS, the full green donut was illuminated. Slowing slightly to 93 KIAS resulted in only the upper (slower airspeed) half of the green donut remaining illuminated. At 103 KIAS the full green donut was illuminated, but accelerating slightly to 104 KIAS resulted in just the lower (faster airspeed) half of the green donut remaining illuminated. This provided a range of 9 KIAS for OAA.
